## **Klondyke Tailings Water Quality Assurance Revolving Fund (WQARF) Site Community Advisory Board (CAB) Meeting**

### **DRAFT MINUTES**

# Klondyke Tailings Water Quality Assurance Revolving Fund (WQARF) Site

## Update- Construction of Erosion Protection and Cap on Upstream pile

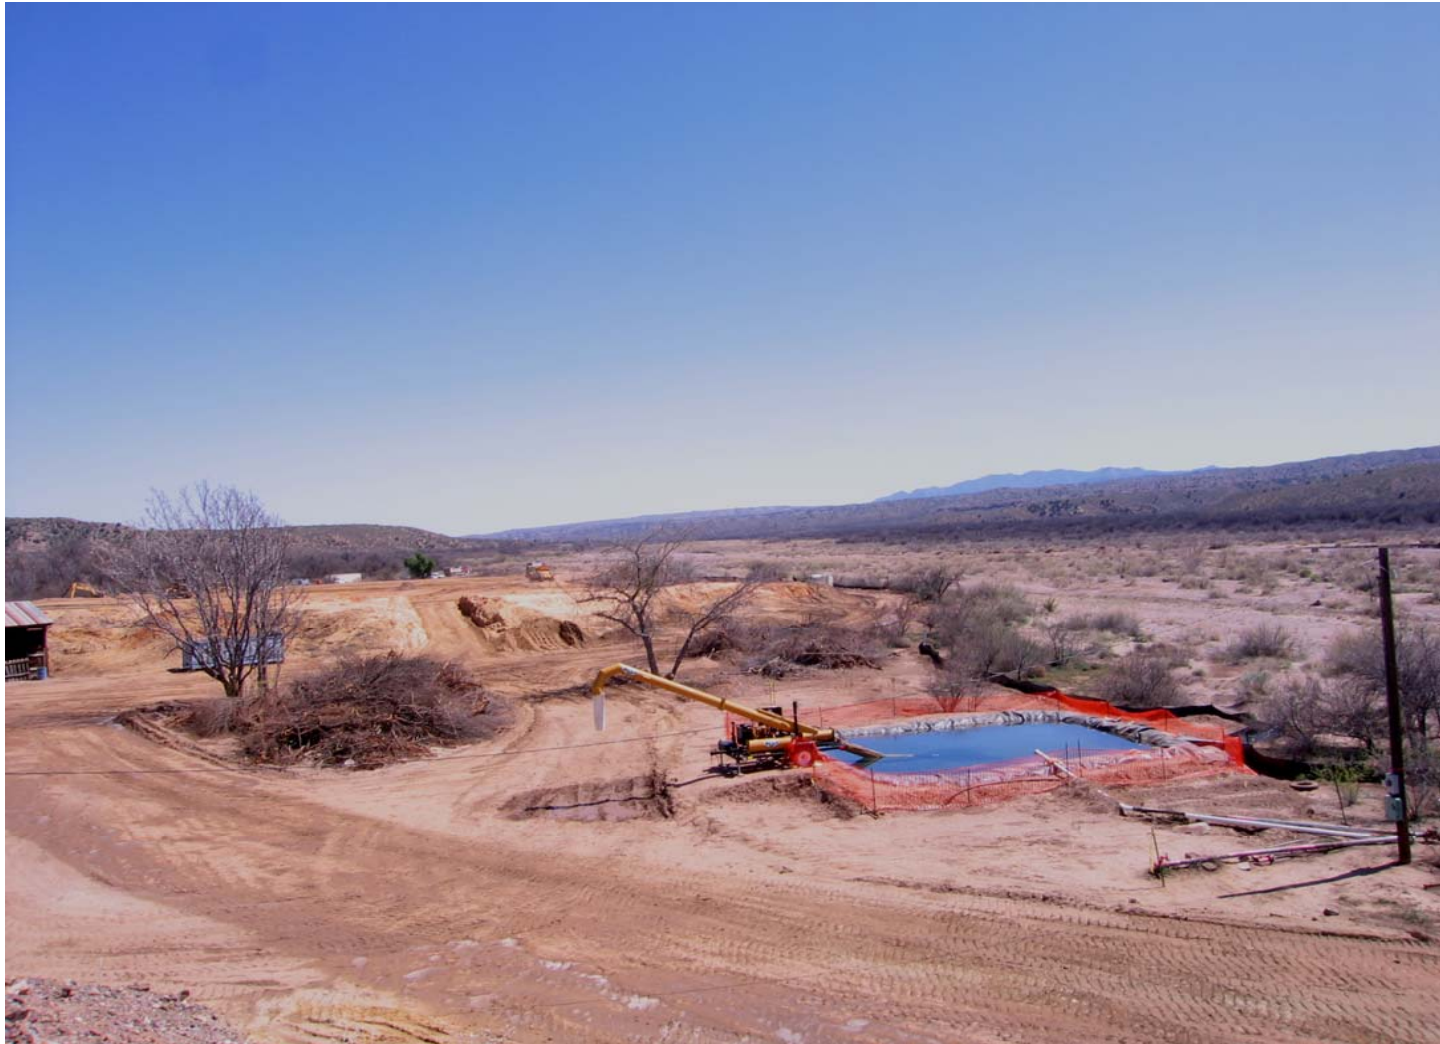
Upstream tailings pile after clearing at start of project

- During June 2008, ADEQ and URS completed installation of erosion protection and clean soil cap on the upstream tailings pile. Total project costs were approximately 3.5 million dollars.

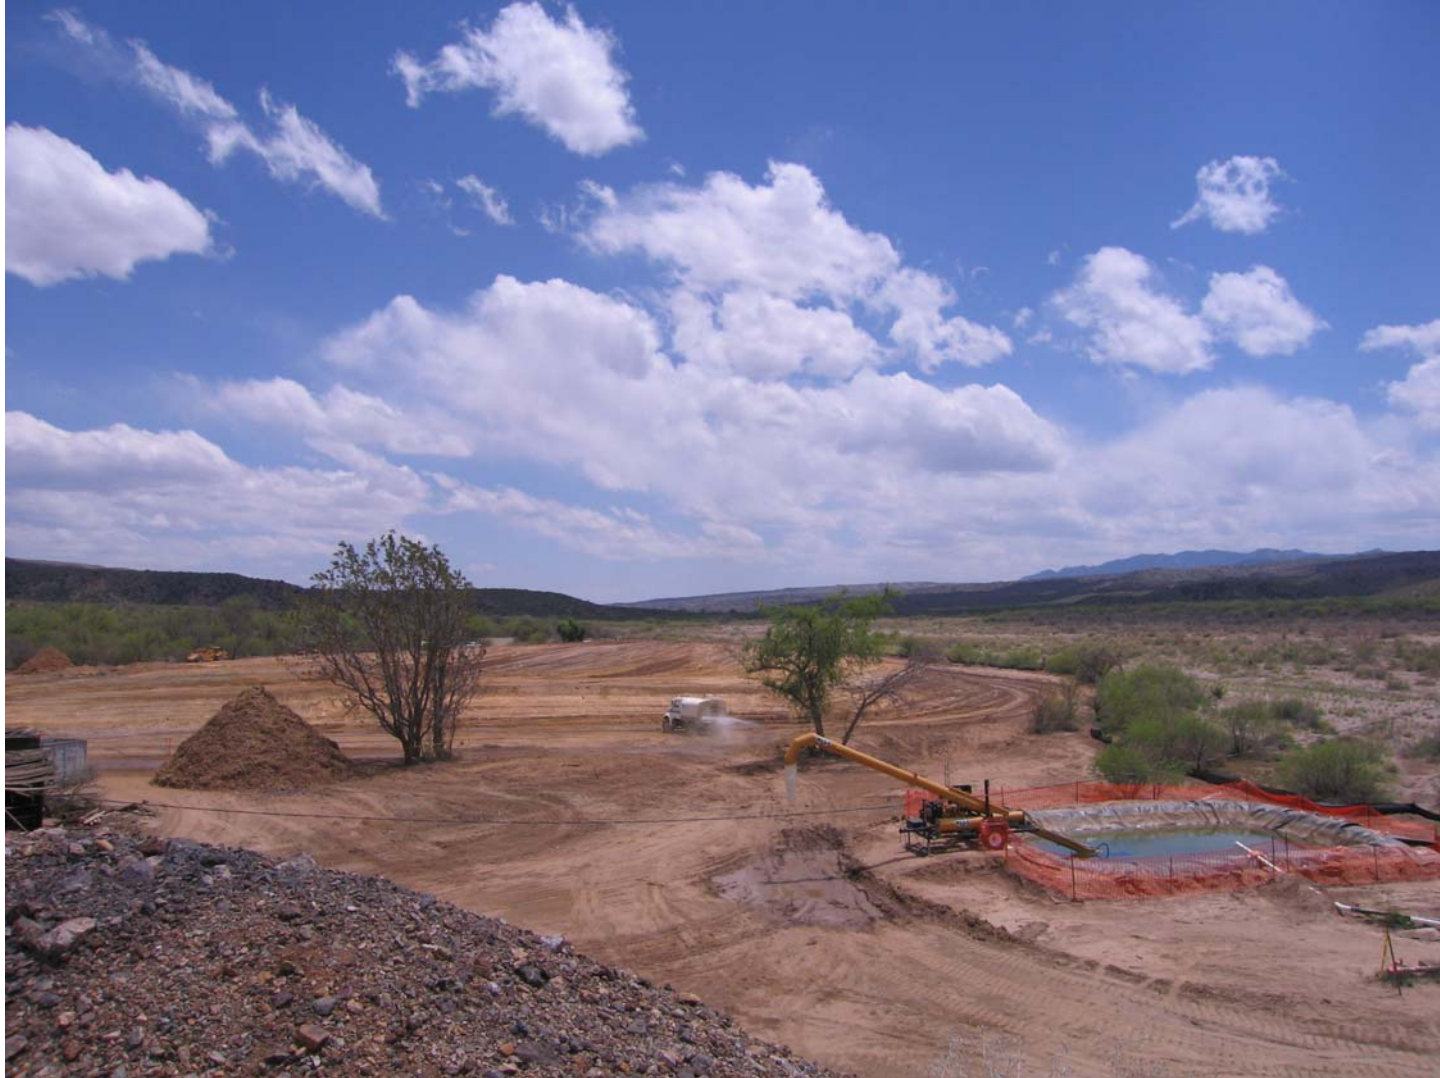
## Rough grade of tailings completed

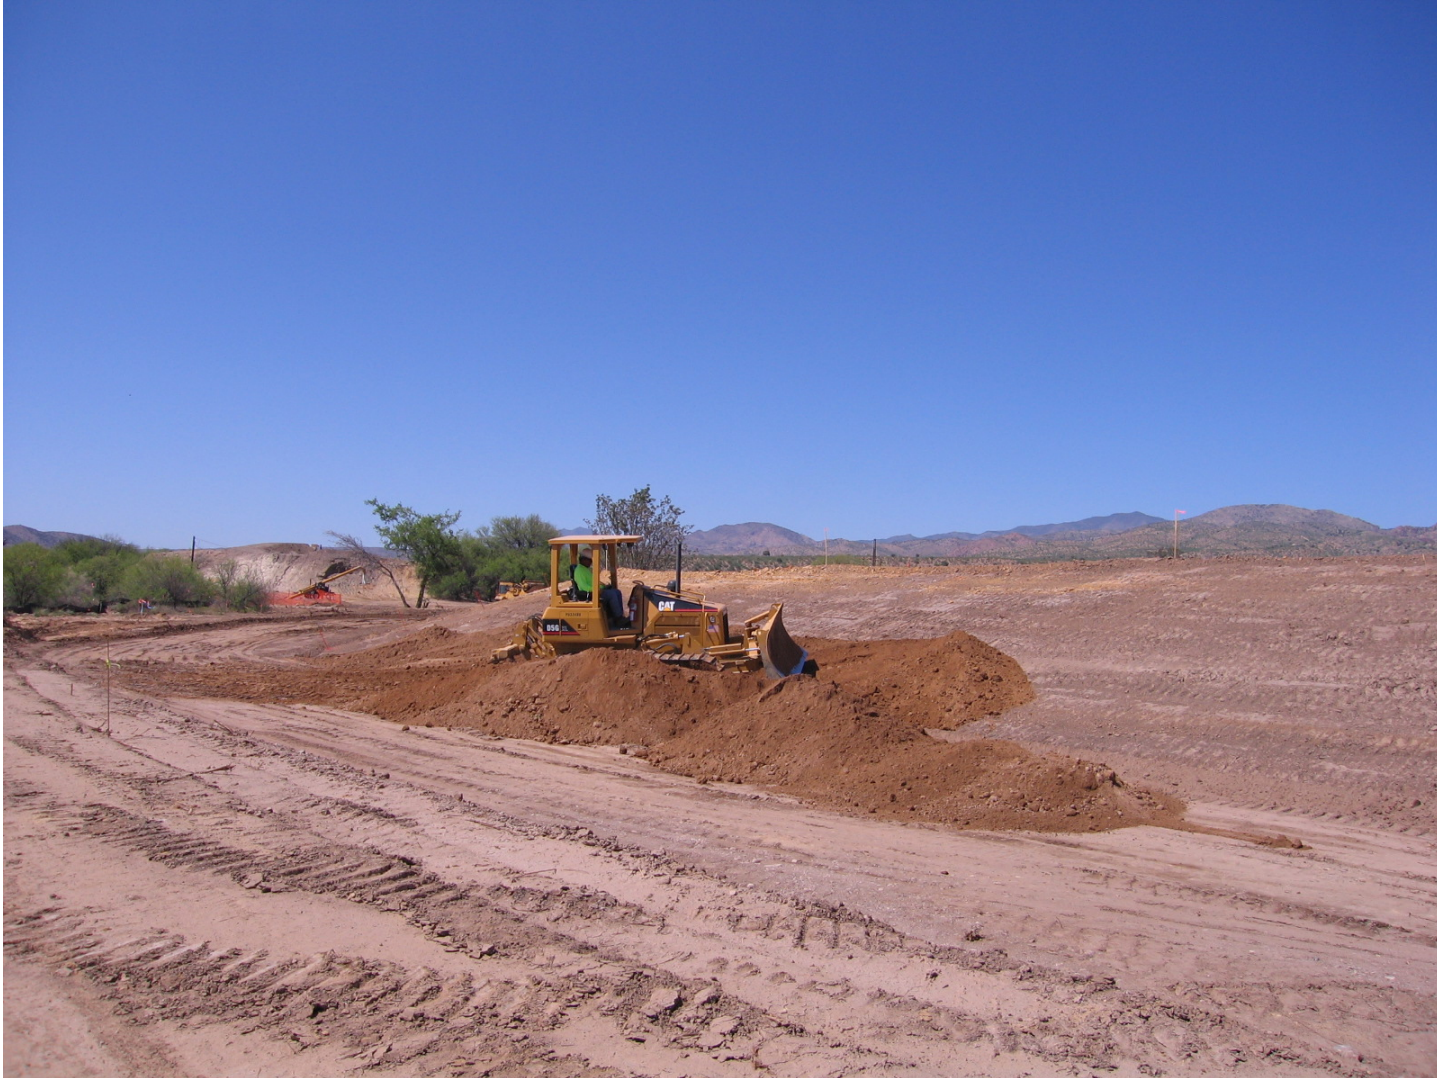
Two feet of clean soil cap placed over tailings

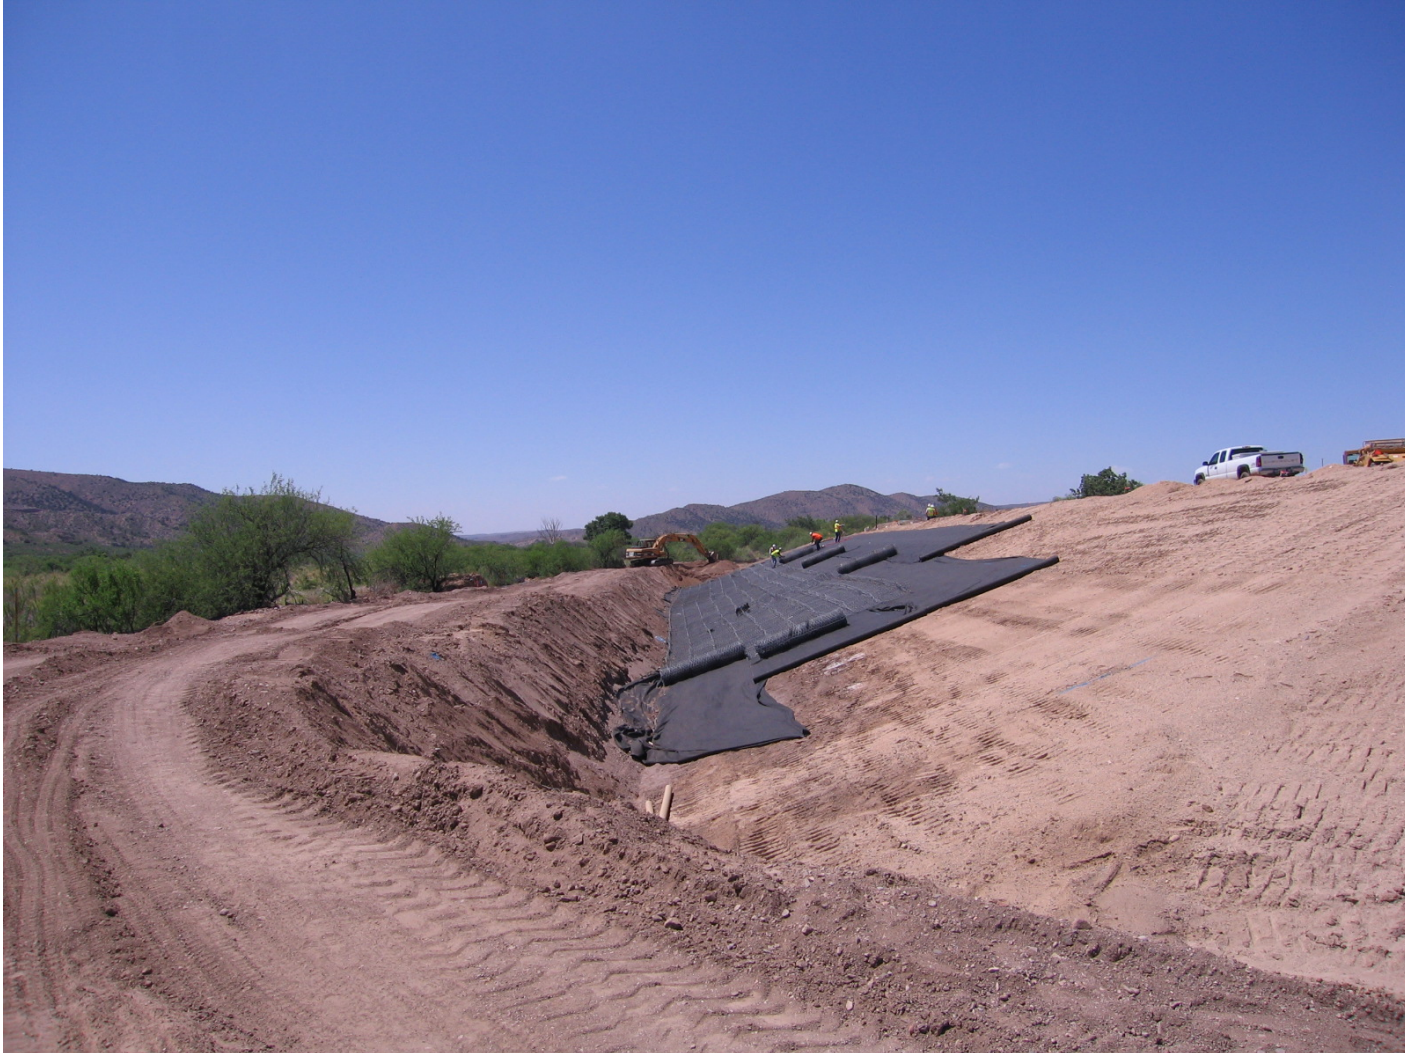
## Installation of geotextile and gabions over clean soil cap

Details regarding the gabion mattress construction and type of seed that was planted on the cap of the upper tailings pile were discussed.

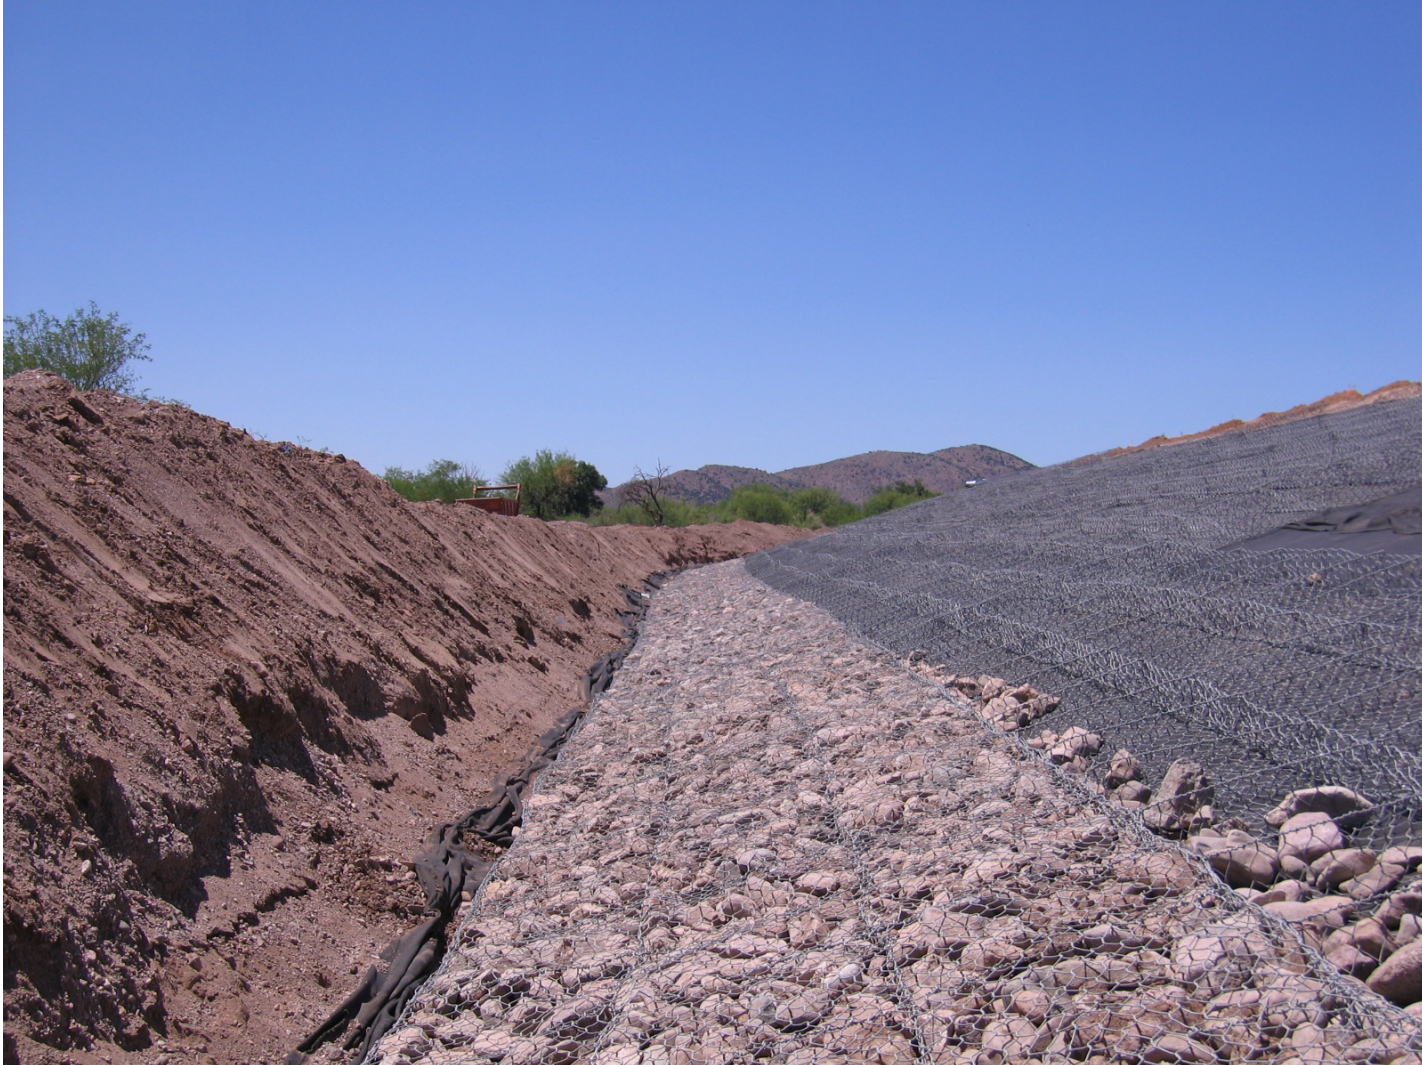
## West side gabion mattresses filled with rip-rap

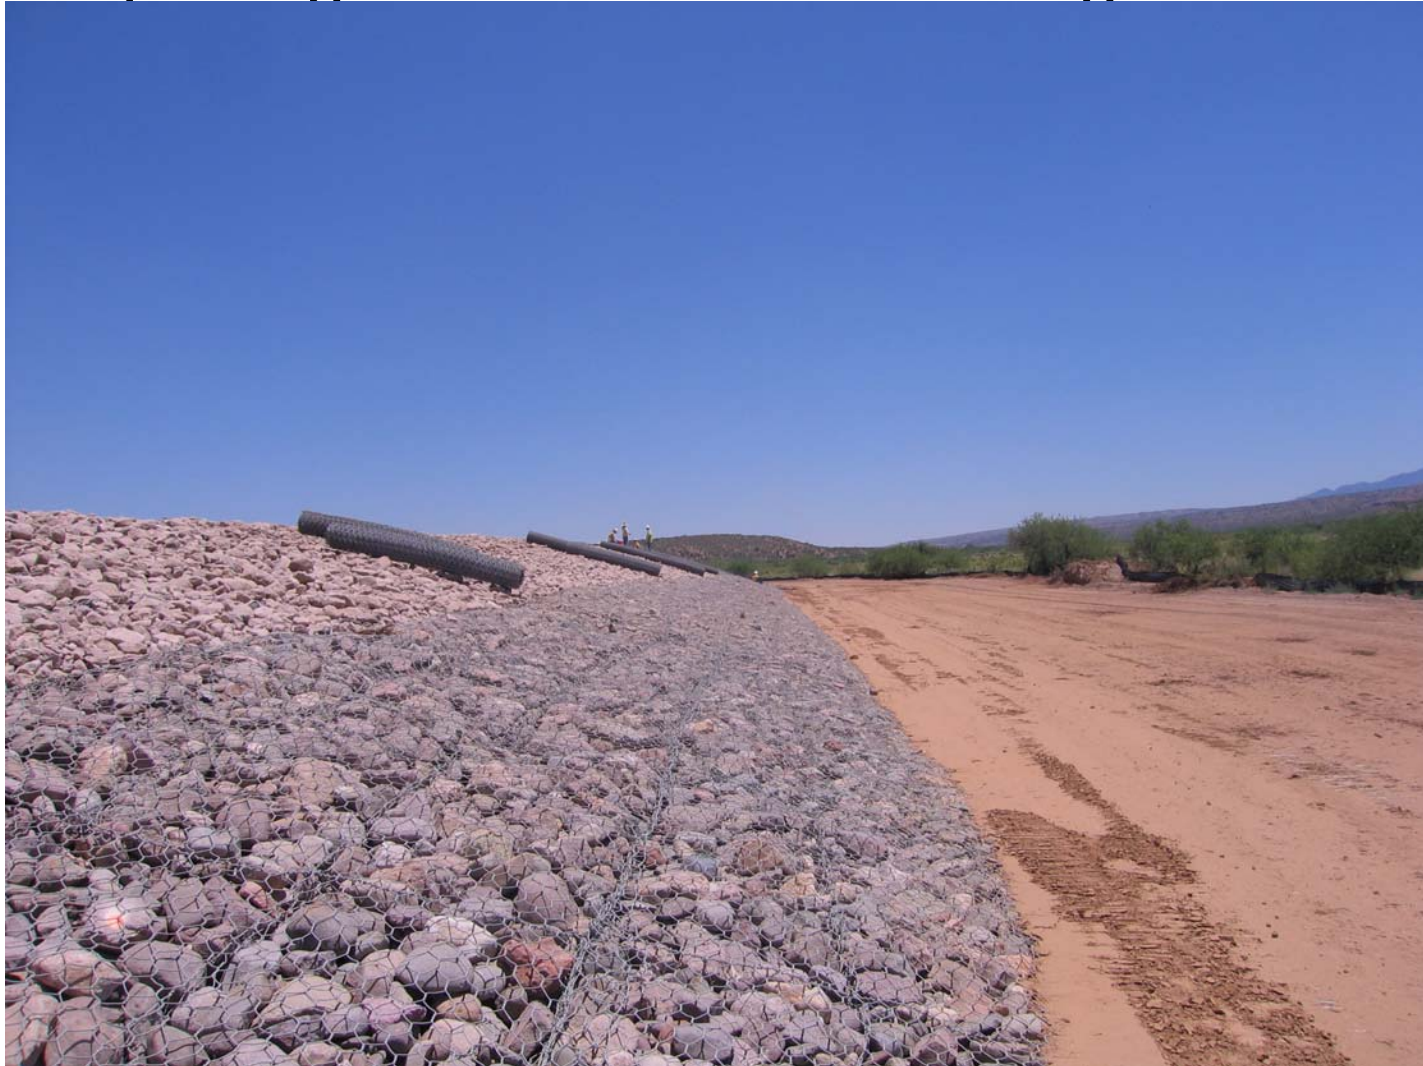
## Tops of gabion mattresses being installed

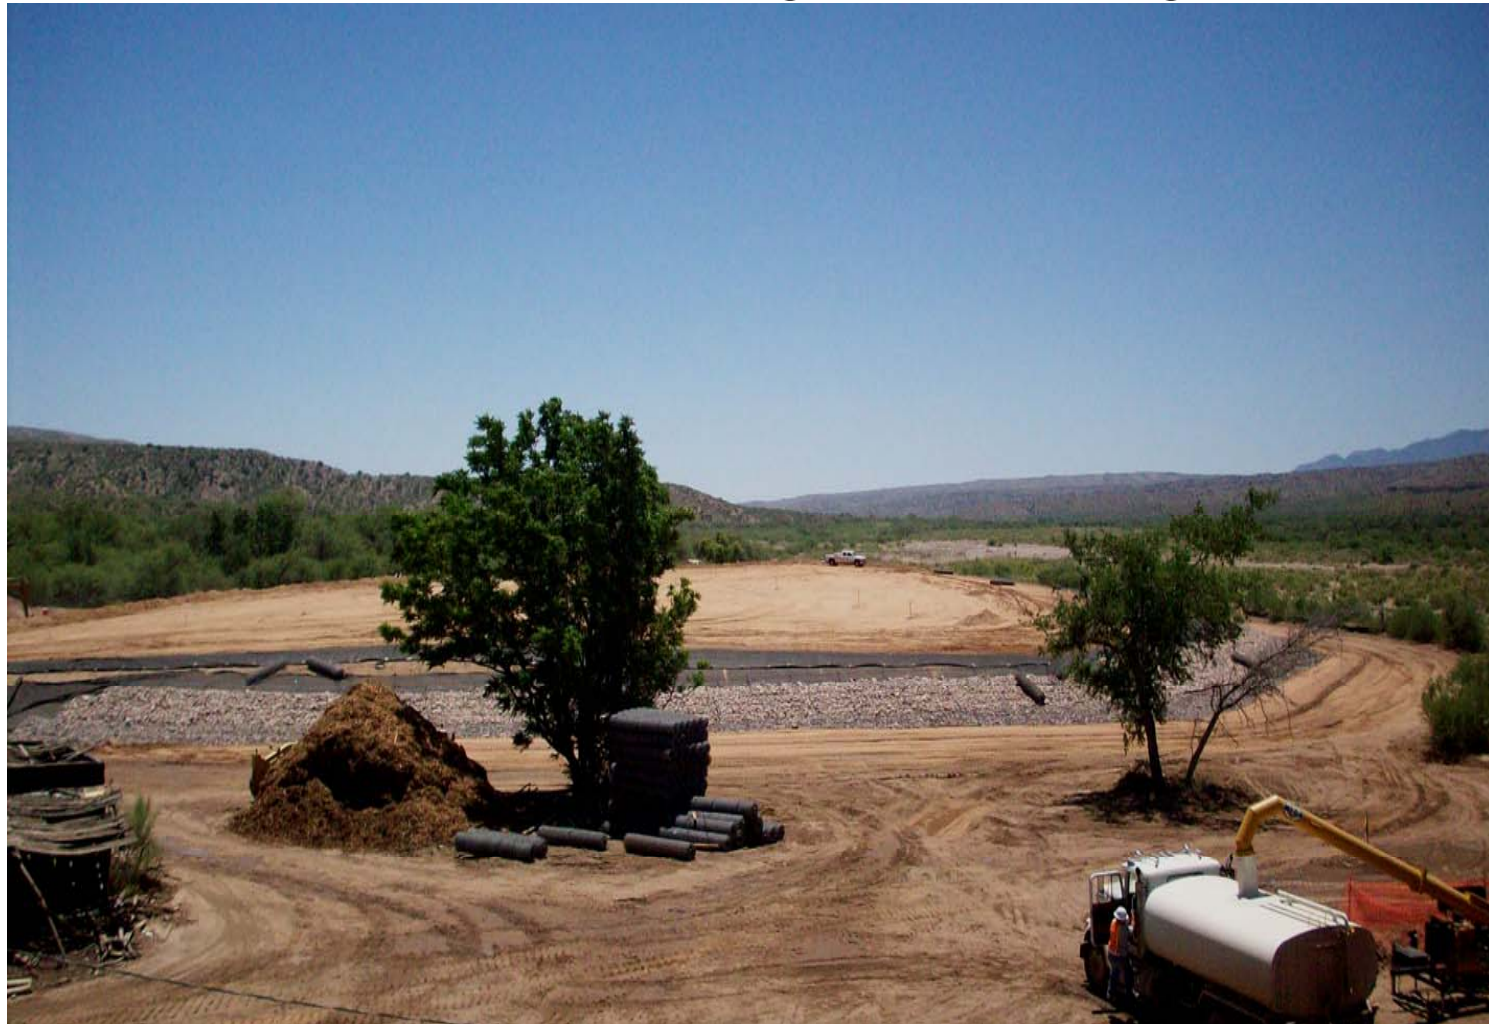
## Overview of upstream tailings pile nearing completion

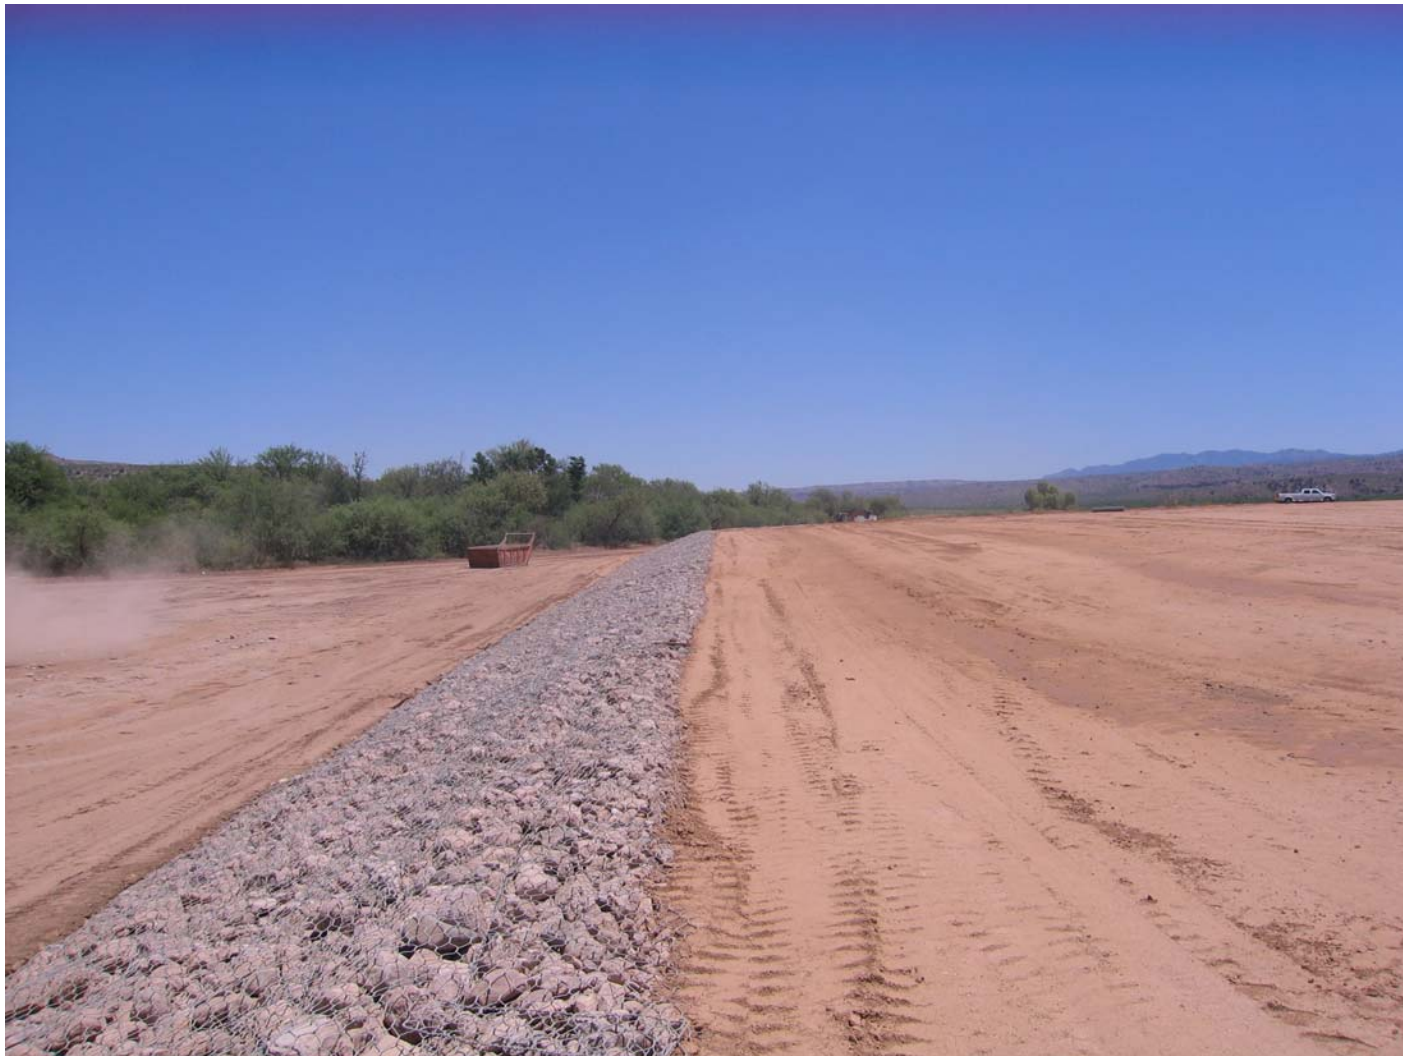
## Gabions mattresses and clean soil cap line

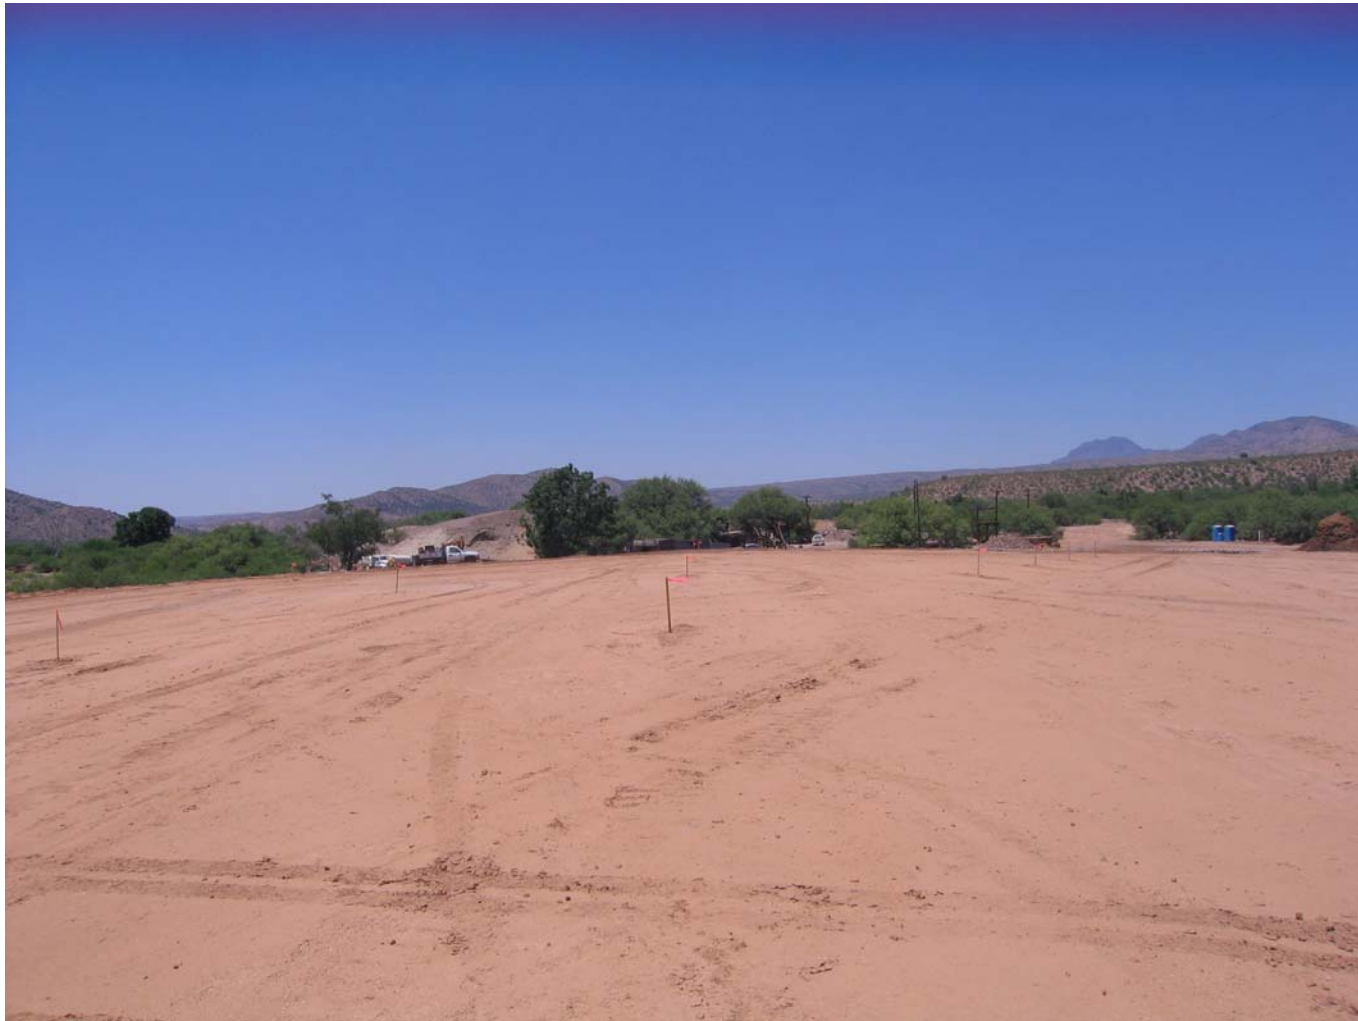
## Final grade of clean soil cap

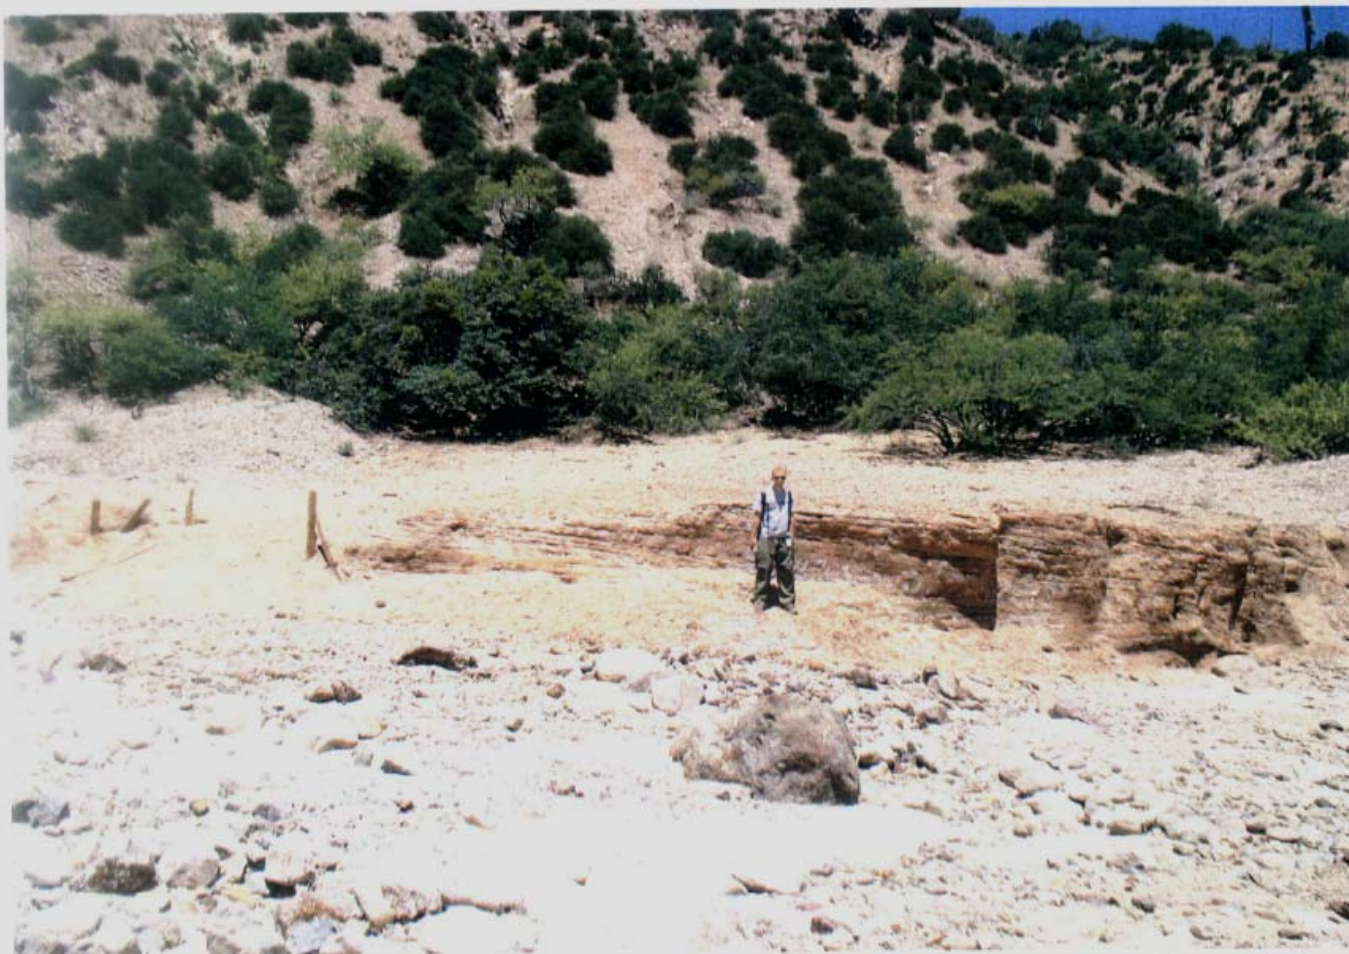
Photograph 2: Tailing pile on west bank of Laurel Creek 1/5-mile south of Grand Reef Mine (upstream to right). Tailings are red-brown silty clay, finely laminated, and display a whitish crust on the exposed face from evaporation of fluids on tailing surface. Samples GR-2 and GR-5 collected here.

- URS visited the Grand Reef Mine area to document the amount and location of tailings and collect soil samples on June 5, 2008.
- Lead concentrations in the area of the mine range from 13,000 to 170,000 parts per million.
- Samples collected by the University of Arizona and ADEQ indicated contribution from material washed down Laurel Canyon may be in the range of 700 to 1,000 parts per million in the area near the Klondyke site.

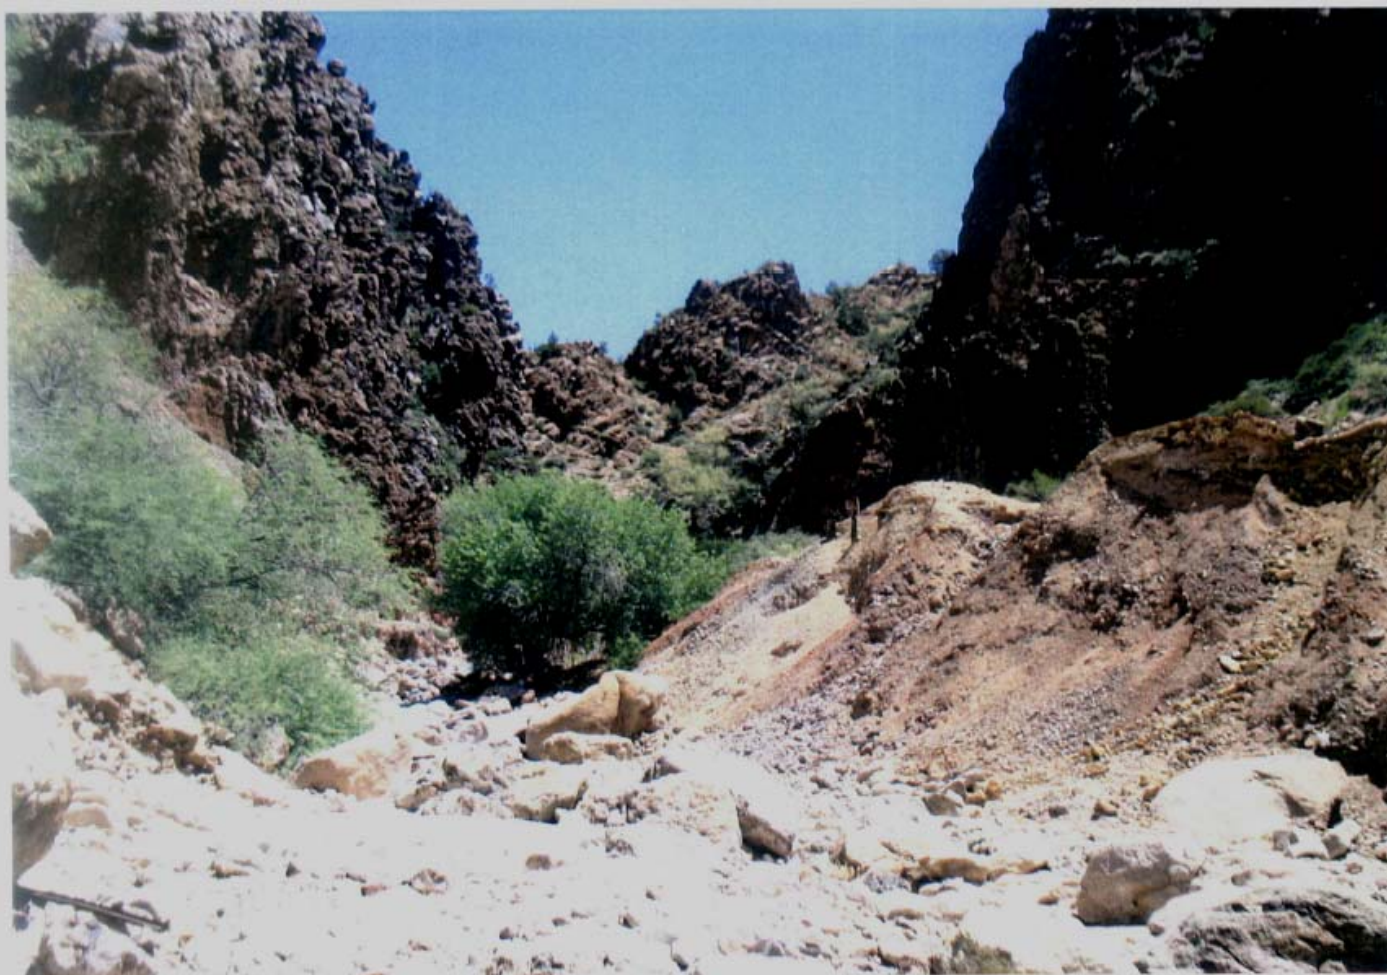
Photograph 4: Laurel Creek downstream from Grand Reef Mine, located in cliff to the left. Red-brown fine-to coarse-grained tailings/waste rock on south bank of creek. View to the northeast.

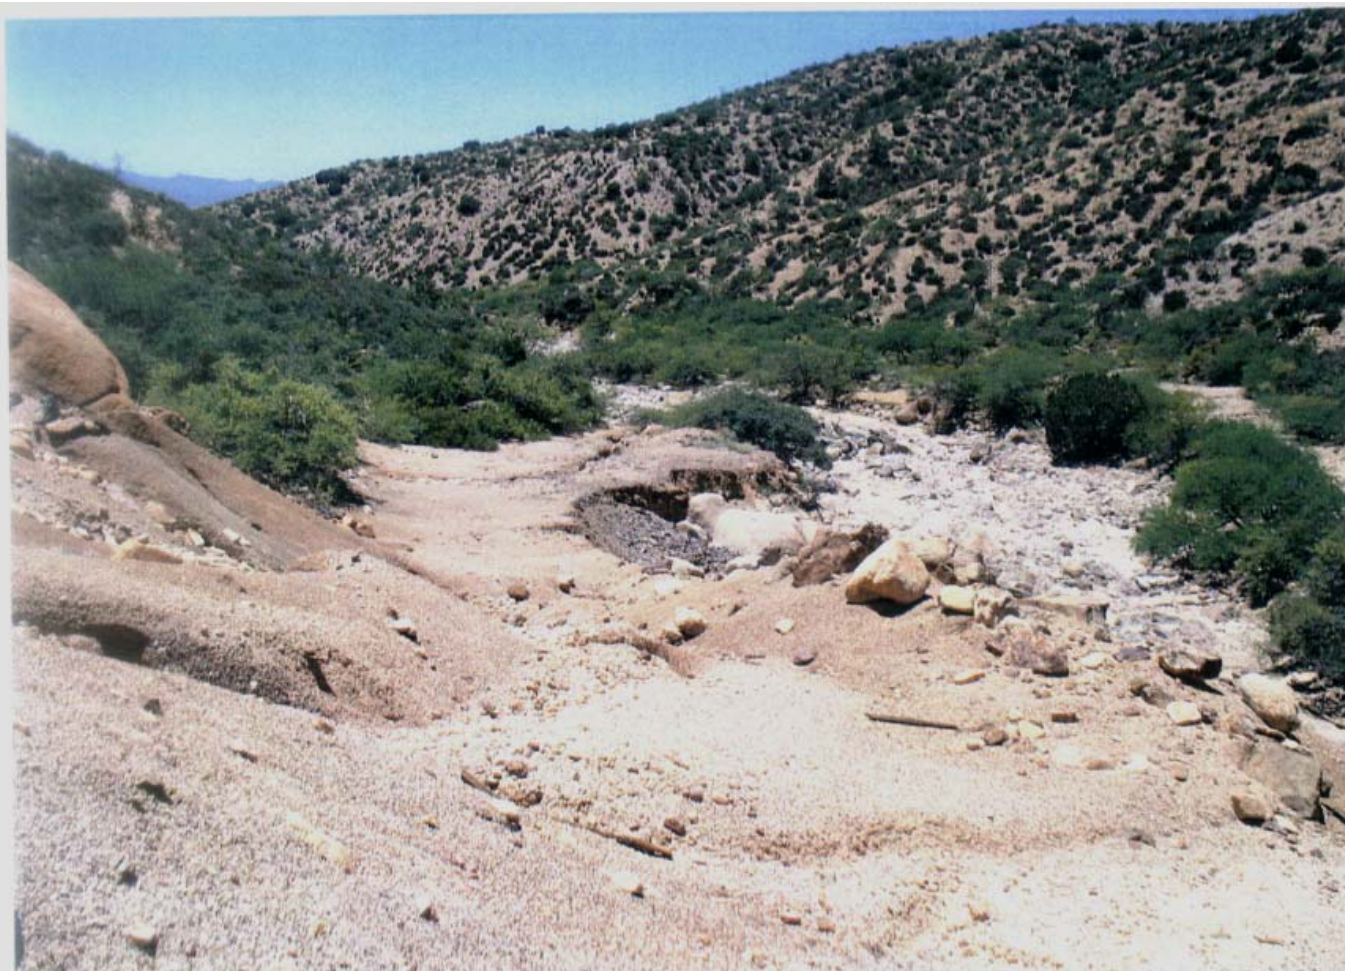
Photograph 6: Tailing or waste rock pile on south side of Laurel Creek across from Grand Reef Mine. View to the southwest.
